Monthly Oversight Report 23
ACS NPL Site
Griffith, Indiana
November 2, 2002 - November 29, 2002

Subject: Monthly Oversight Summary Report
No. 23 for November 2002

Monthly Oversight Summary Report No. 23
ACS Superfund Site WA57, 46526.238

Reporting Period: Month of November (November 2, 2002 - November 29, 2002)

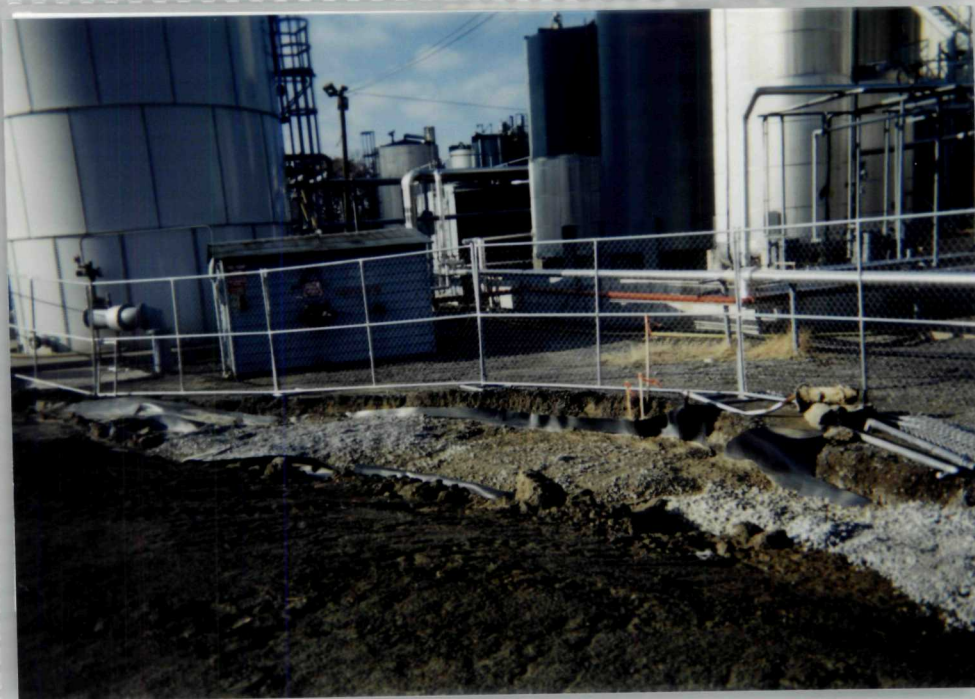
Description: Photo facing north from the ACS breakroom building showing the stormwater line to be re-covered.

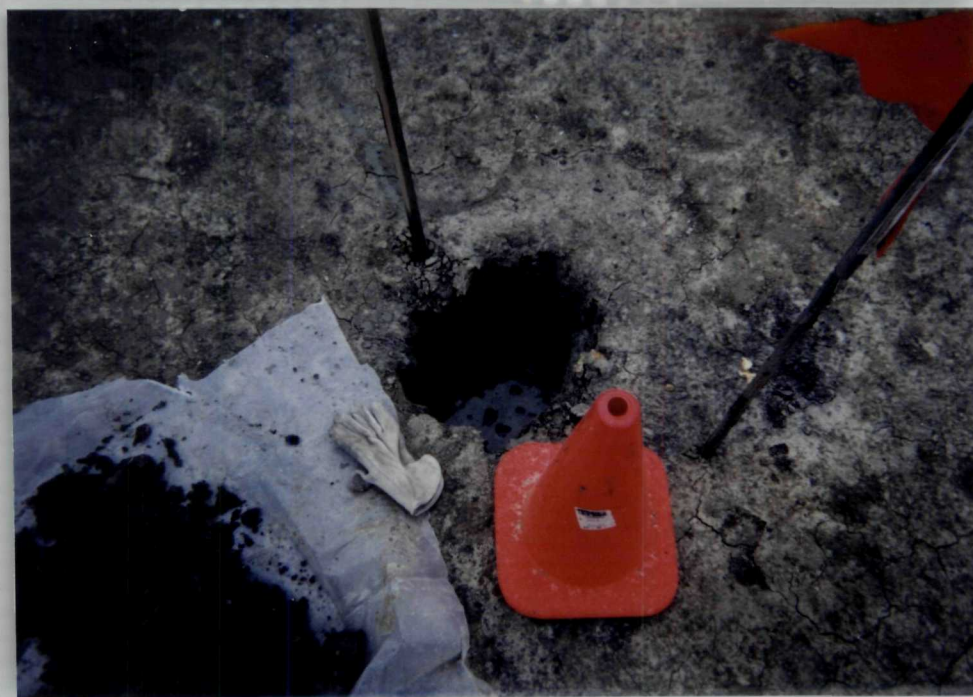
During the week of November 4, a crewmember of Area Survey potentially injured his knee by stepping into a depression while walking between survey sites. MWH is following up to see what is the crewmember's current condition.

Description: Photo facing east showing the abandoned borehole where the Area Survey crewmember was injured. Borehole has been mostly backfilled with cement grout.

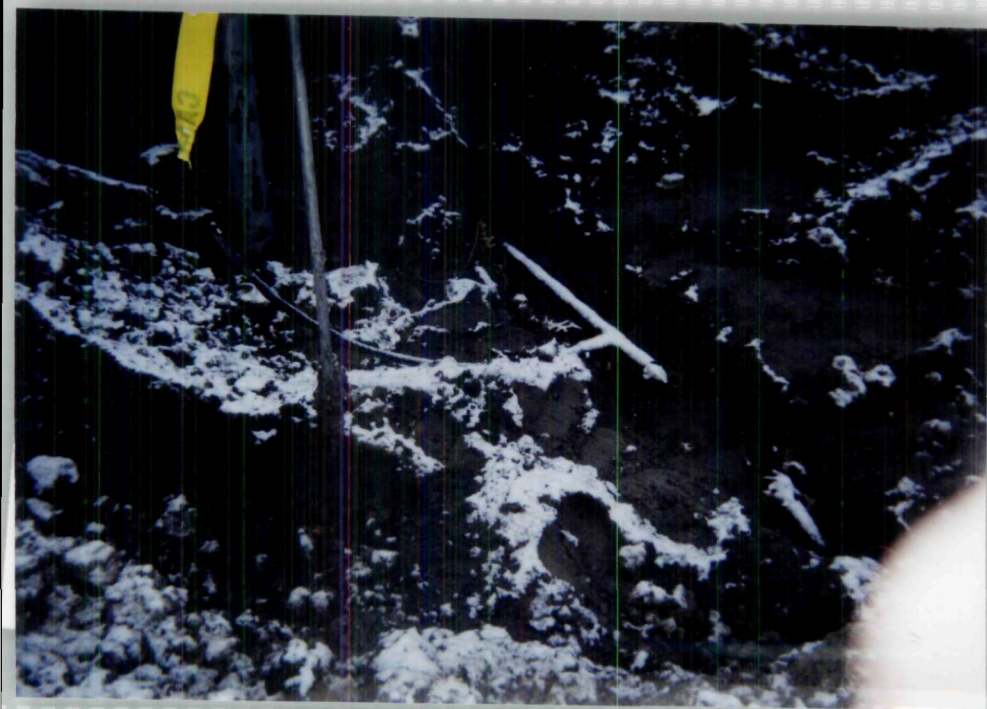
BLA drilled into the 3-inch diameter groundwater conveyance piping while drilling well SVE-46. MWH earlier had pressurized the conveyance piping so that BLA would detect if the piping was damaged. BLA relocated the well and proceeded to install SVE-46.

IES repaired the damaged 3-inch-diameter groundwater conveyance piping that was damaged during drilling activities on November 22, 2002. During pressure testing, IES found that the piping was damaged at two other locations in addition to the location near SVE-46. IES excavated the piping in these areas and found that the damage was at the 1-inch-diameter whips installed off of the groundwater conveyance piping. IES completed the repairs and successfully pressure tested the piping. IES began installing the pitless adaptors and saddles for the dual phase extraction wells. IES inerted the wells using an inflatable plug and nitrogen. IES measured the oxygen level and the LEL prior to drilling into the wells. IES also performed continuous air monitoring using a PID, and personnel wore half-face respirators while working in the excavation.

Description: Photo facing northwest showing the damage to the 3-inch-diameter groundwater conveyance piping located near ONCA SBPA ISVE well SVE-46.

Independent Environmental Services (IES) completed repairing the 3-inch-diameter groundwater conveyance pipe that was damaged near SVE-46 by Boart Longyear & Associates during the On-Site Containment Area (ONCA) Still Bottoms Pond Area (SBPA) in-situ soil vapor extraction (ISVE) well installation. IES proceeded to repair the two other locations where damage was observed in the groundwater conveyance piping and successfully pressure tested the piping. The locations where additional damage had occurred were located at the 1-inch-diameter whips that extend off of the main 3-inch-diameter line.

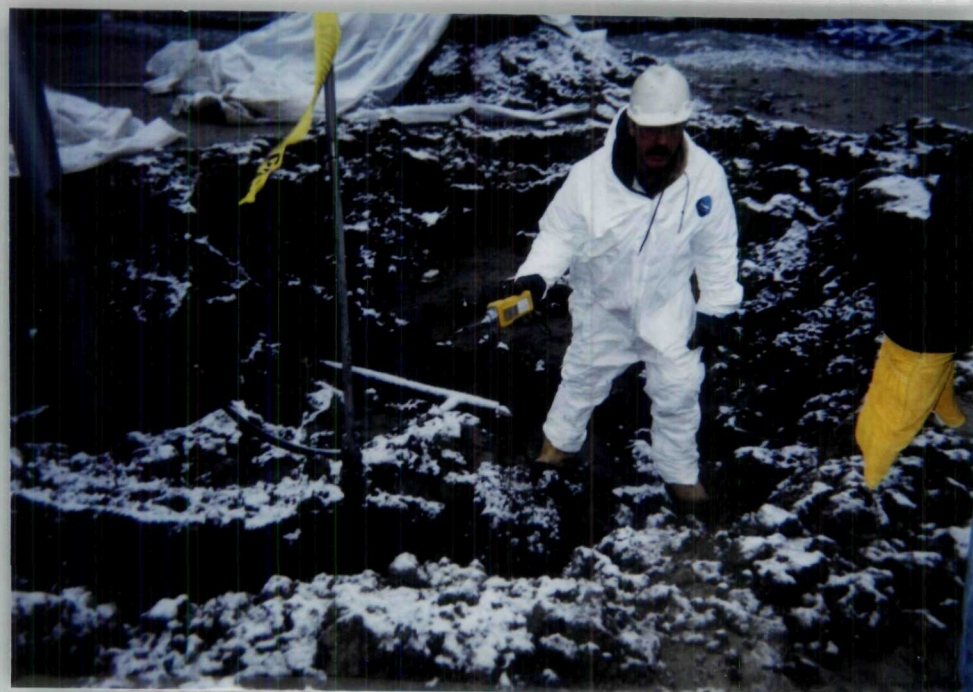
Description: Photo facing northwest showing IES performing air monitoring of the excavation near ONCA SBPA ISVE well SVE-46.
